# PENNSPECT LLC Testing & Inspections

## SUMMARY REPORT

## CONFIDENTIAL INSPECTION REPORT

2121 Sunny Circle, Nicetown , Pa 18000

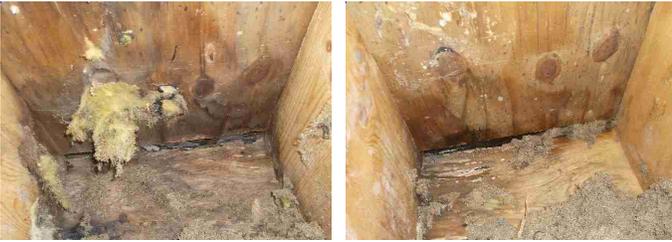
There is carpenter ant damage to a section of the rim joist at the rear of the crawlspace. Evidently a repair was done in the area, with the replacement of some of the sub-flooring. The damage to the rim joist does not appear to be of structural significance, and the condition leading to moisture intrusion into the area evidently has been corrected. There was no apparent indications of an active infestation of carpenter ants, however we recommend the area be monitored in warmer weather.

There is carpenter ant damage - *Continued*

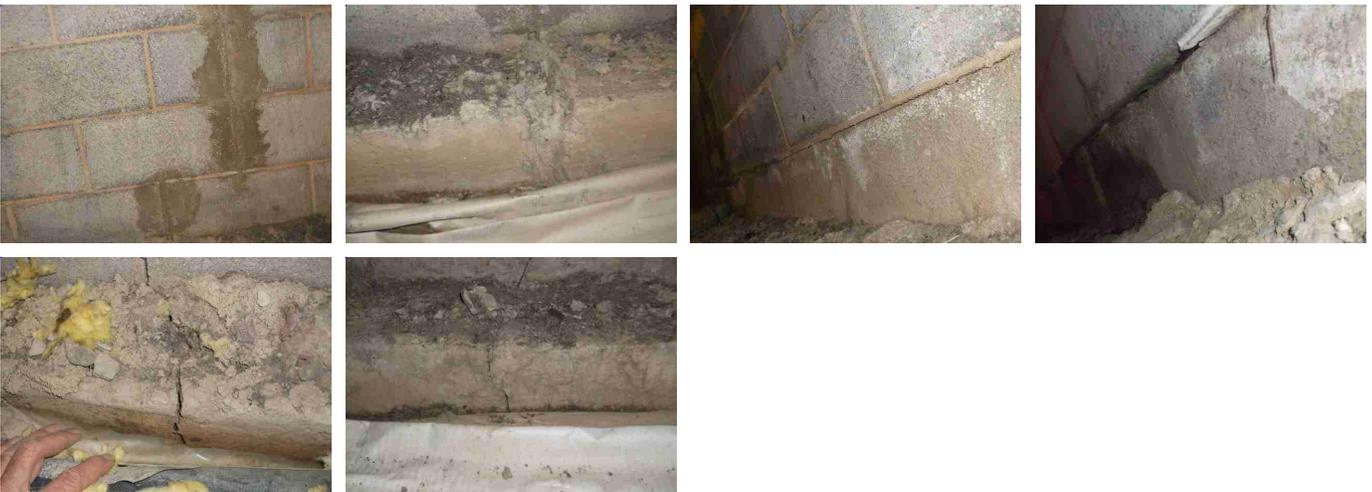
There are horizontal cracks, with displacement, in the block walls that should be evaluated by a specialist. There are horizontal cracks around most of the front crawlspace above the first course of block. The crack along the front and left side involves displacement of the block wall of approximately 3/8 of an inch. The crack on the right side wall involves displacement of 3/4 to 1 inch. There are also step, and vertical cracks, some of which have penetrated the footer. The condition should be evaluated by a structural specialist.
